ENGINEERING REPORT

FAA CONTRACT NO. DTFA03-02-C-00044 PHASE 1, CLIN 0001e (TASK 5) - REMOVAL OF SPECIMENS REPORT

This report documents the physical disassembly of retired aircraft N474DA to remove specimens for destructive evaluation. The objective of the disassembly was to remove the target structures required for evaluation without subjecting them to puncture, overload, or any other damage that would render them unusable for the intended research.

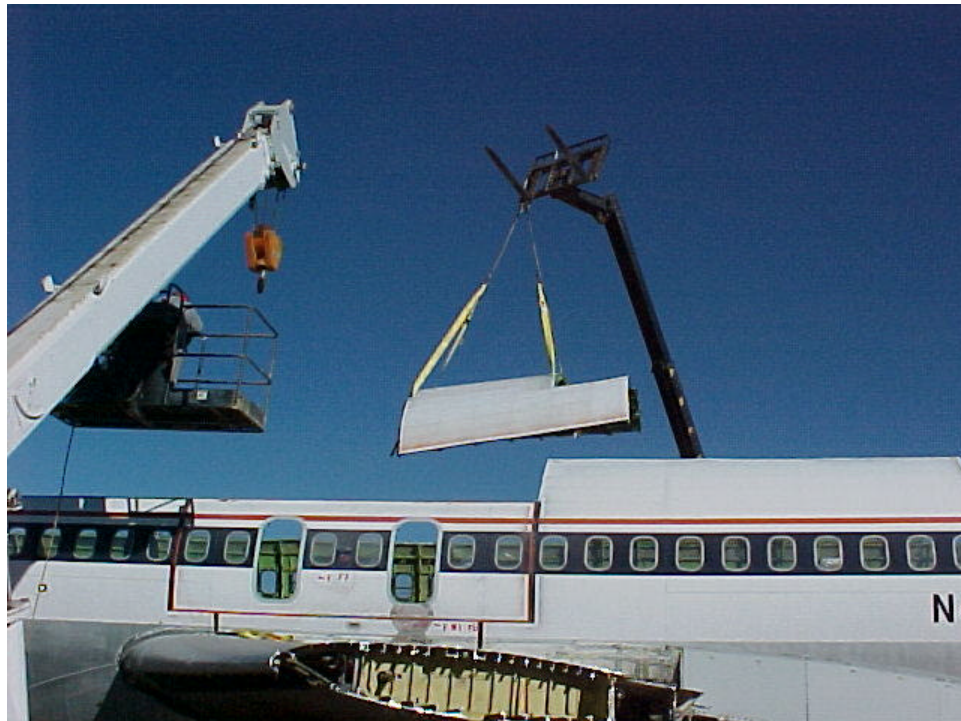
Figure 34: Overhanging crown section removed

Figure 34: Overhanging crown section removed

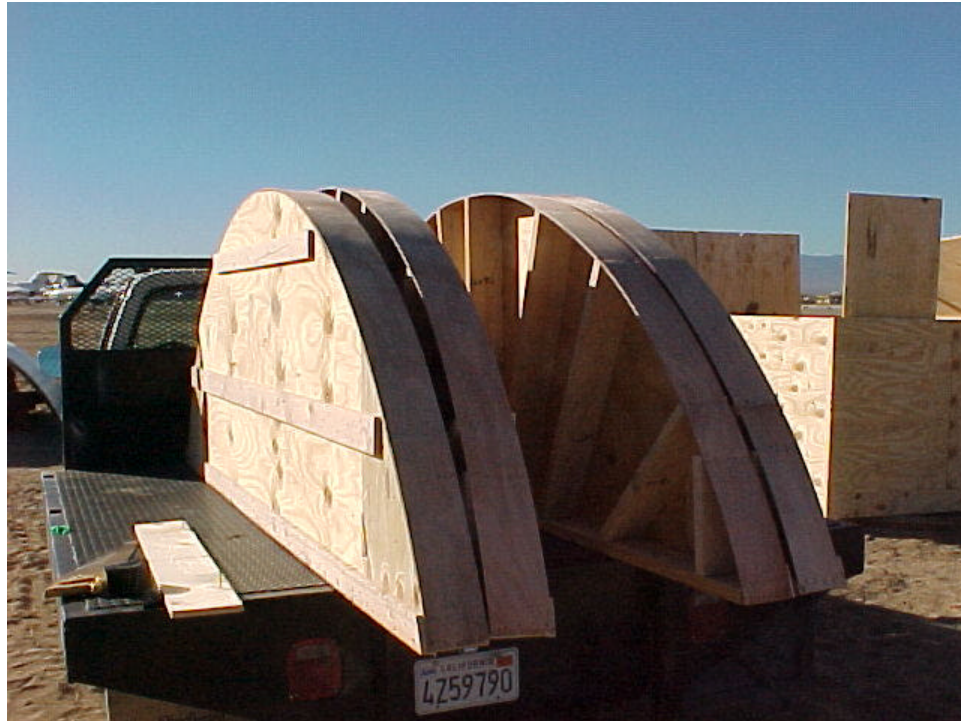
Figure 35: Support ribs for crown panel boxes

Figure 35: Support ribs for crown panel boxes

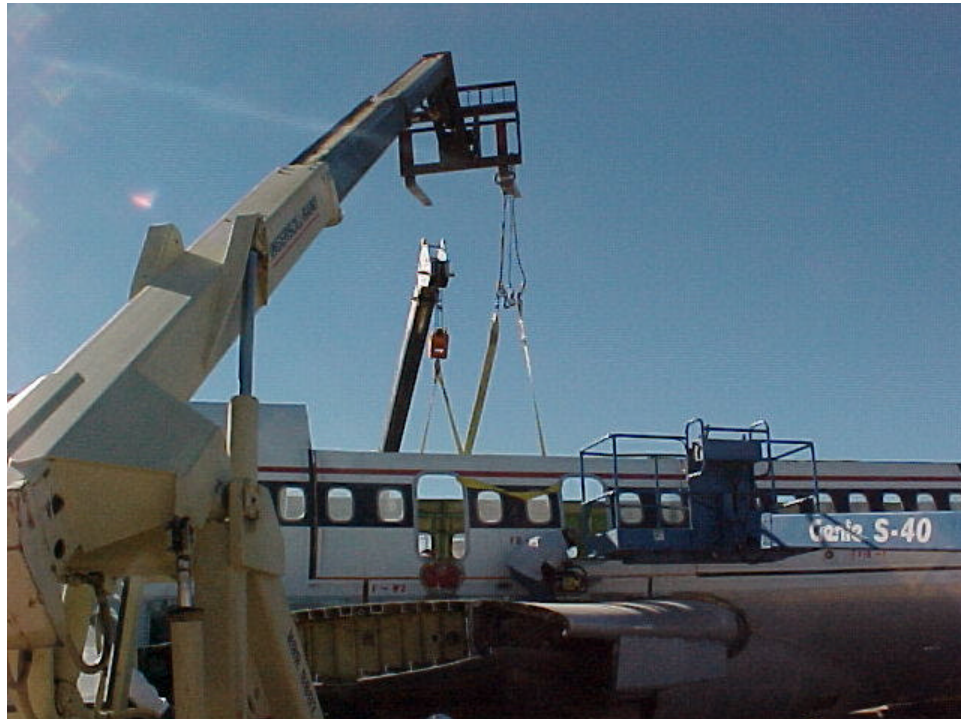
Figure 36: F8 ready to be cut

Figure 36: F8 ready to be cut

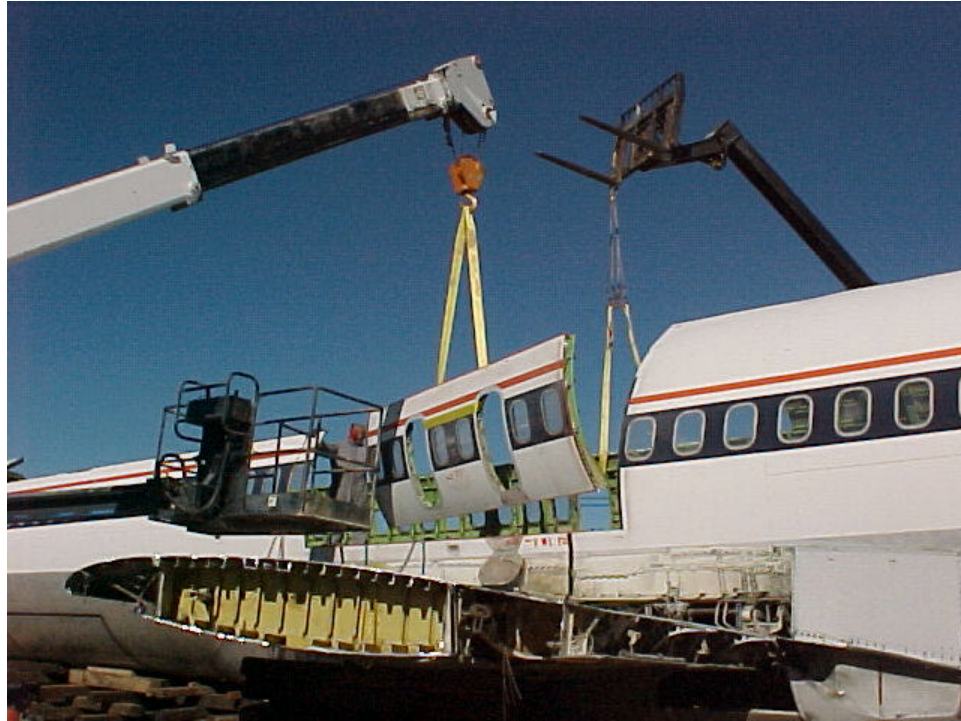
Figure 37: F7 removed

Figure 37: F7 removed

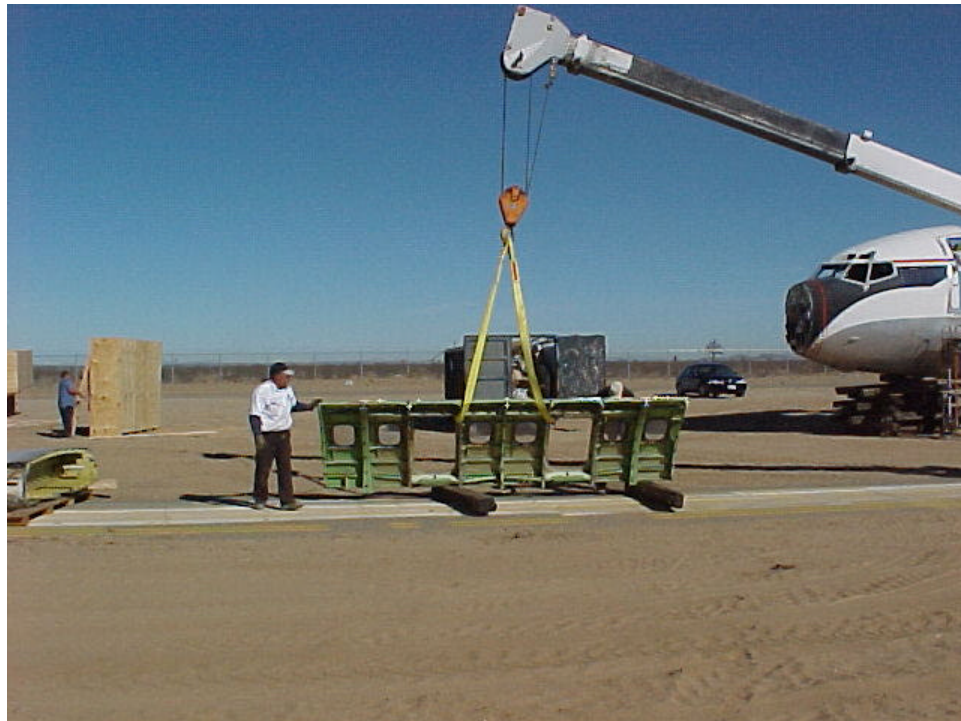
Figure 38: F7 lowered to staging ties

Figure 38: F7 lowered to staging ties

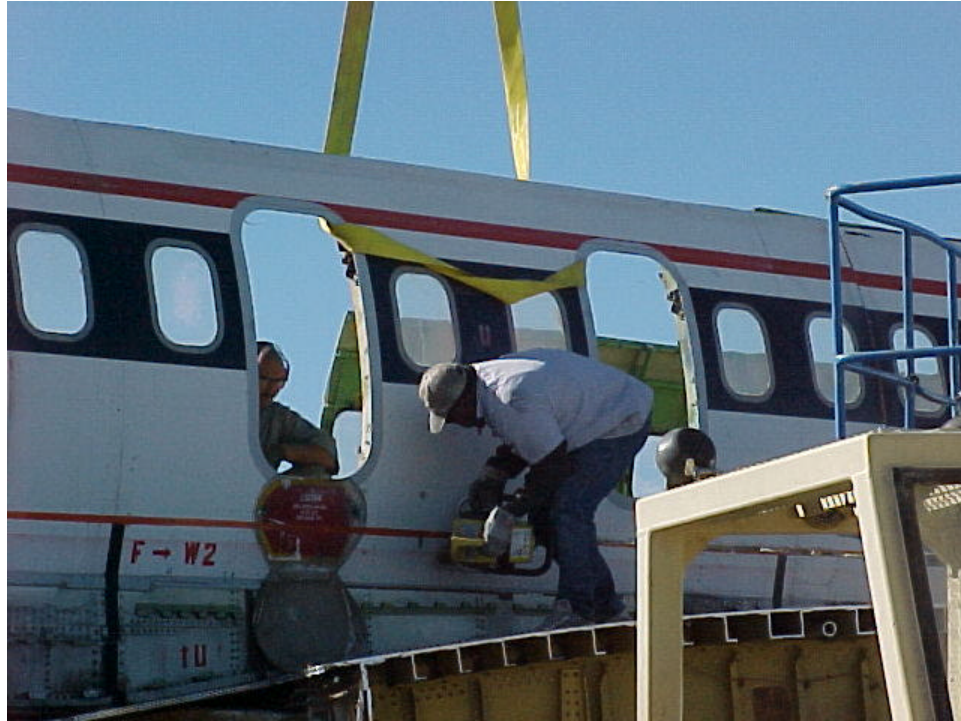
Figure 39: Cutting F8

Figure 39: Cutting F8

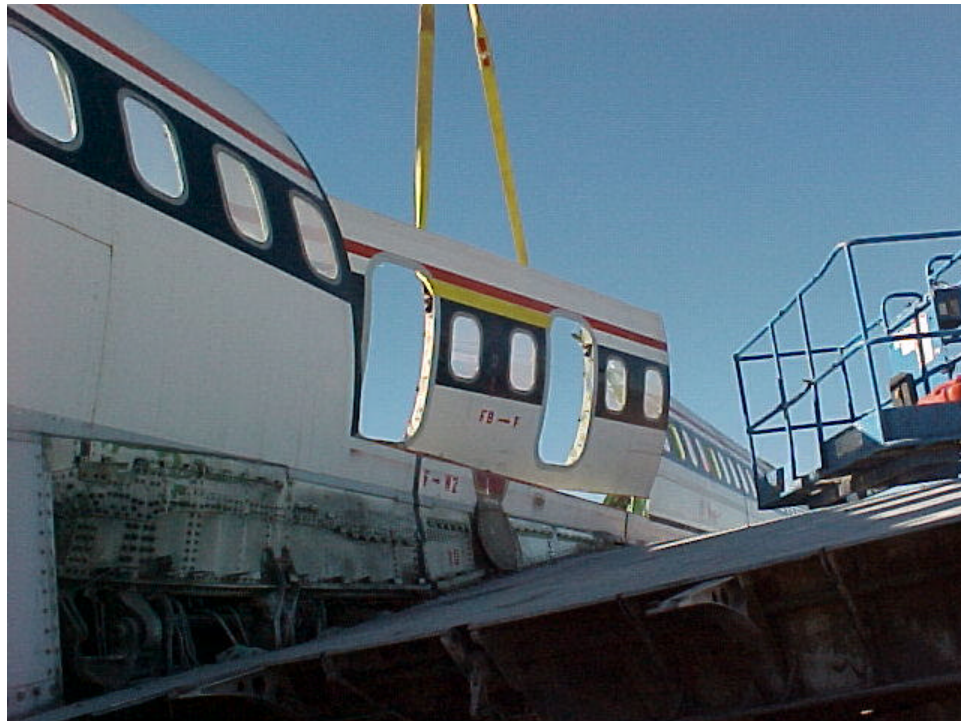
Figure 40: Removing F8

Figure 40: Removing F8

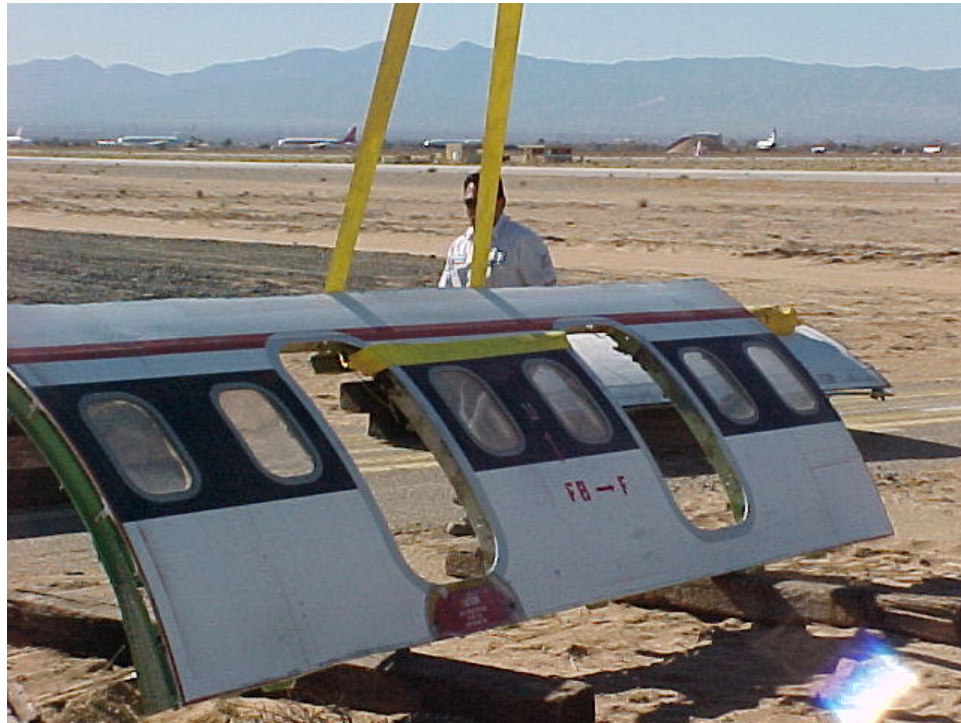
Figure 41: Staging F8

Figure 41: Staging F8

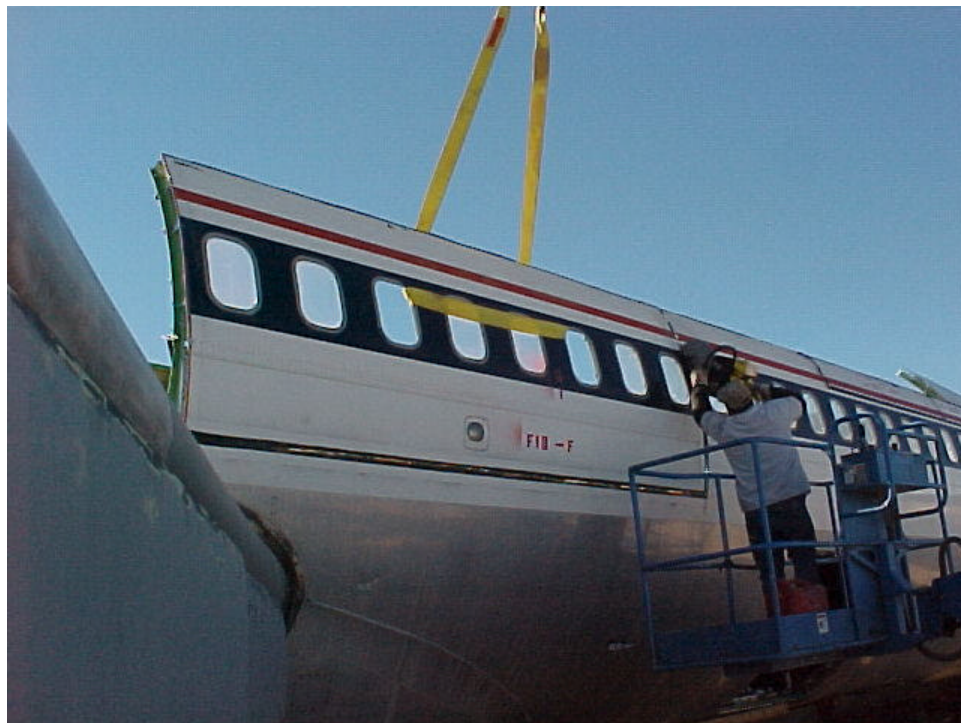
Figure 42: Cutting F10

- F10 was lifted with a single strap looped through two window cutouts, approximately 1/3 and 2/3 of the panel length.
 - The forward edge of F10 was inadvertently struck on the lift boom of the crane/forklift. However, the only damage evident is to the frame at the forward cut-line, which was already damaged by the cutting saw.

Figure 42: Cutting F10

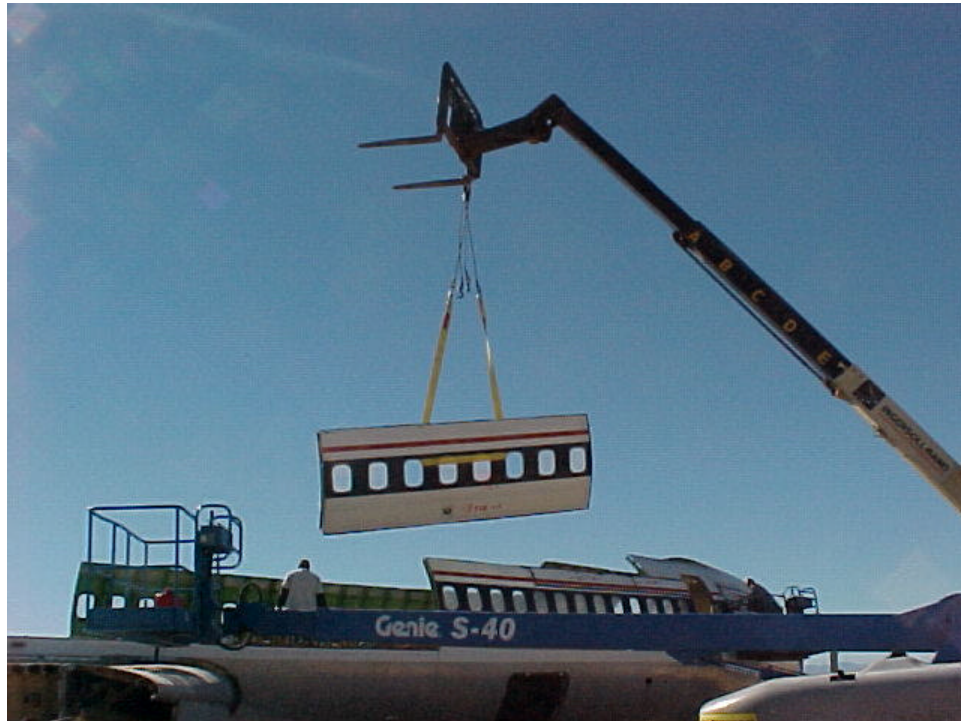
Figure 43: Lifting F10

Figure 43: Lifting F10

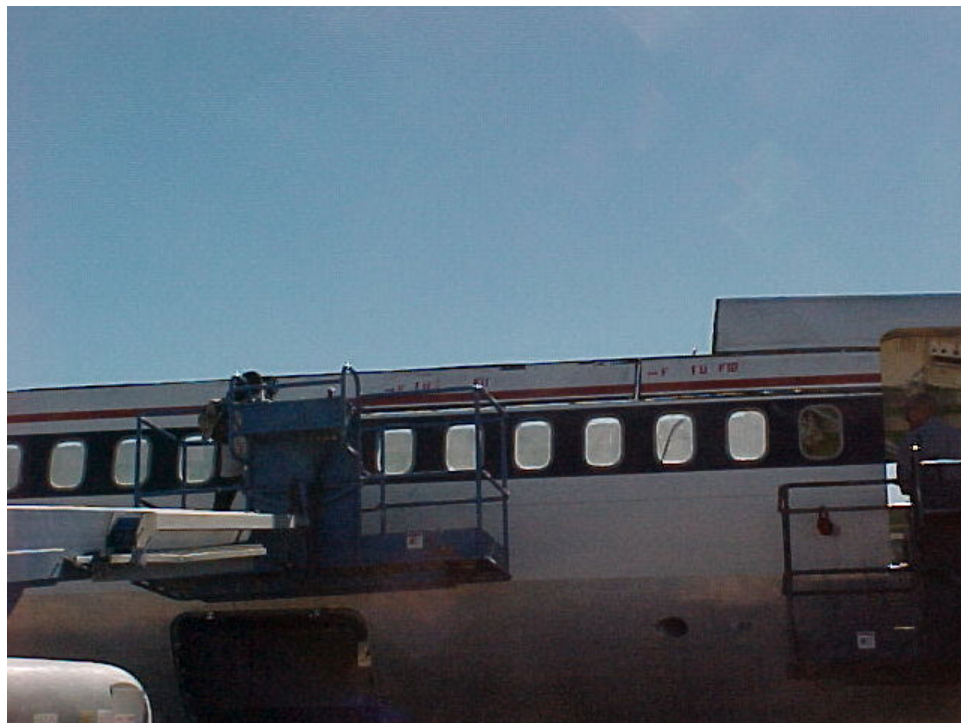
Figure 44: Cutting F11 and F12

Figure 44: Cutting F11 and F12

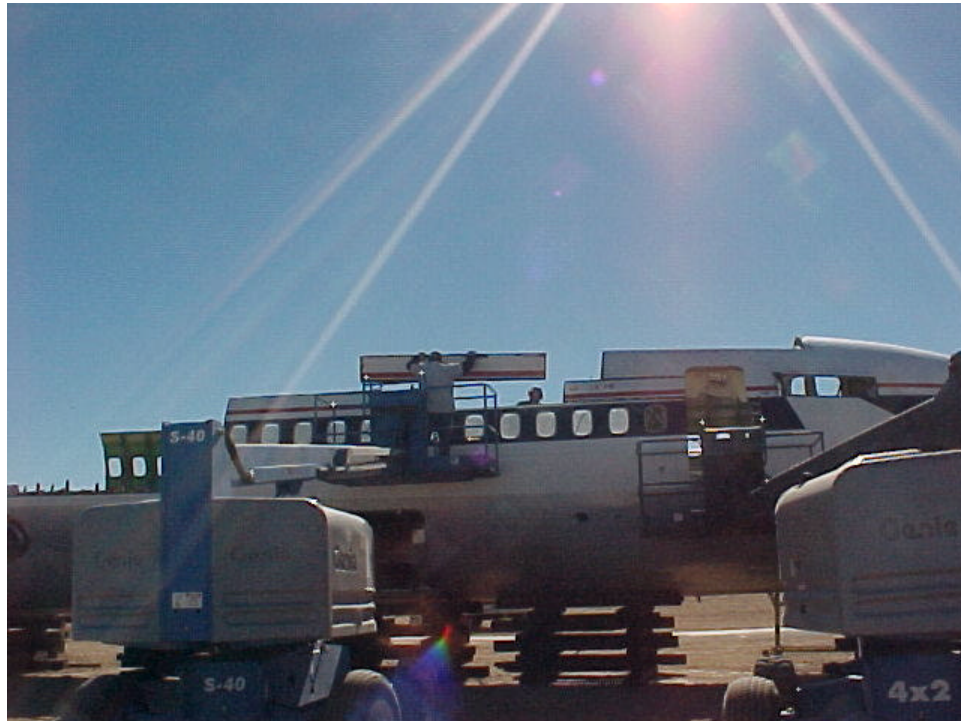
Figure 45: Removing F11

Figure 45: Removing F11

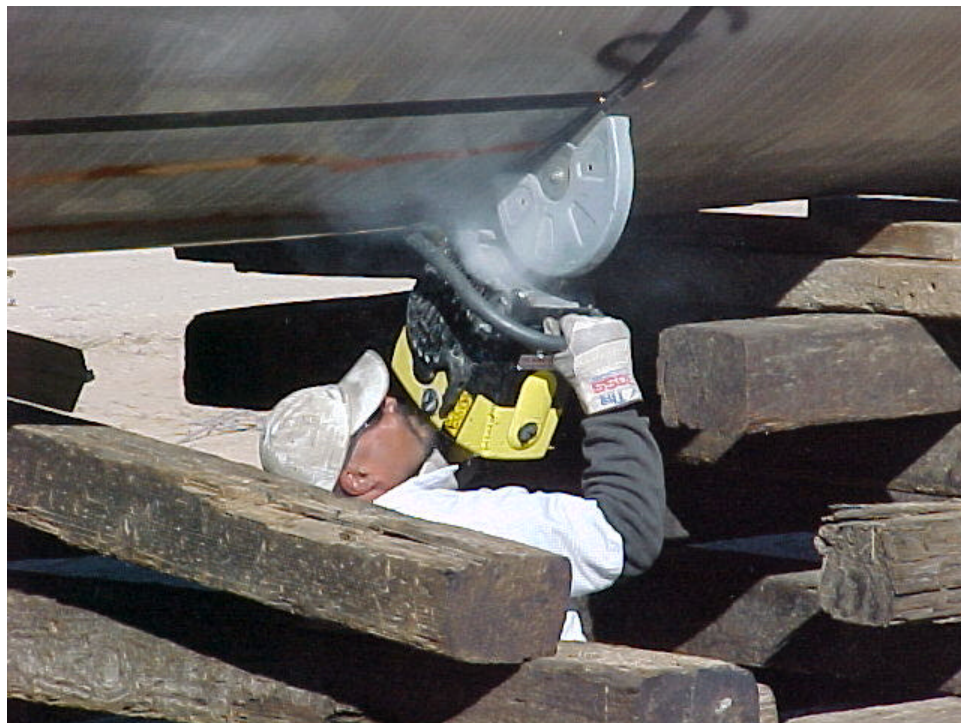
Figure 46: Cutting F9

Figure 46: Cutting F9

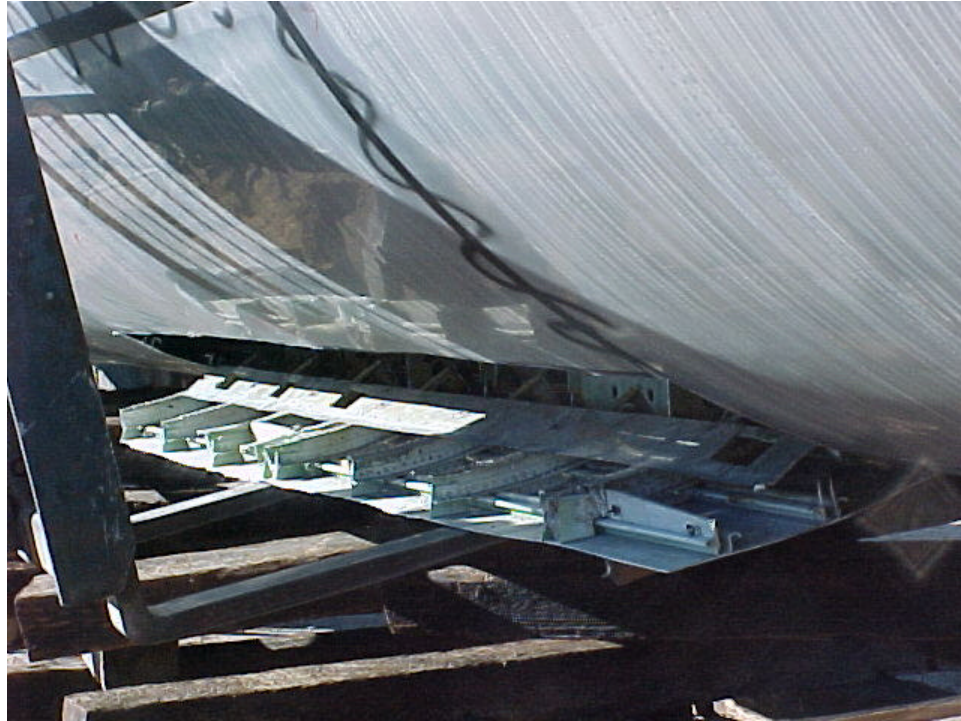
Figure 47: Lowering F9

Figure 47: Lowering F9

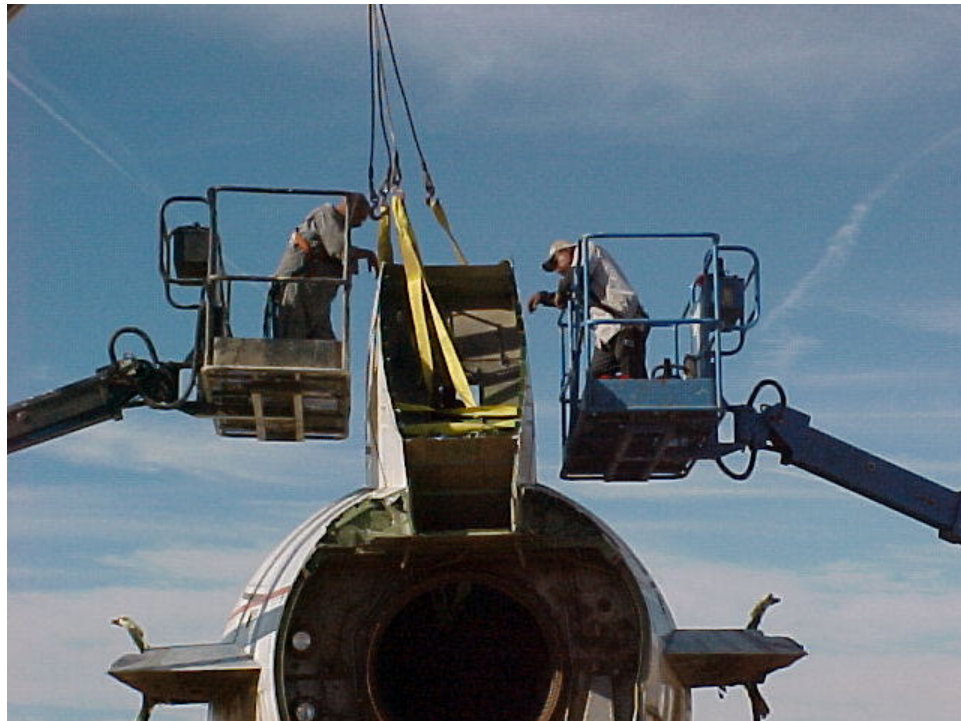
Figure 48: Cutting FN1 and FN2

- Cut and removed the vertical stabilizer rib and stringer attachments (FN1 and FN2) in one piece.
 - Note that stringer repairs already exist at S-4R, S-5R, S-6R, and S-8R. The skin splice stringer is S-7R.

Figure 48: Cutting FN1 and FN2

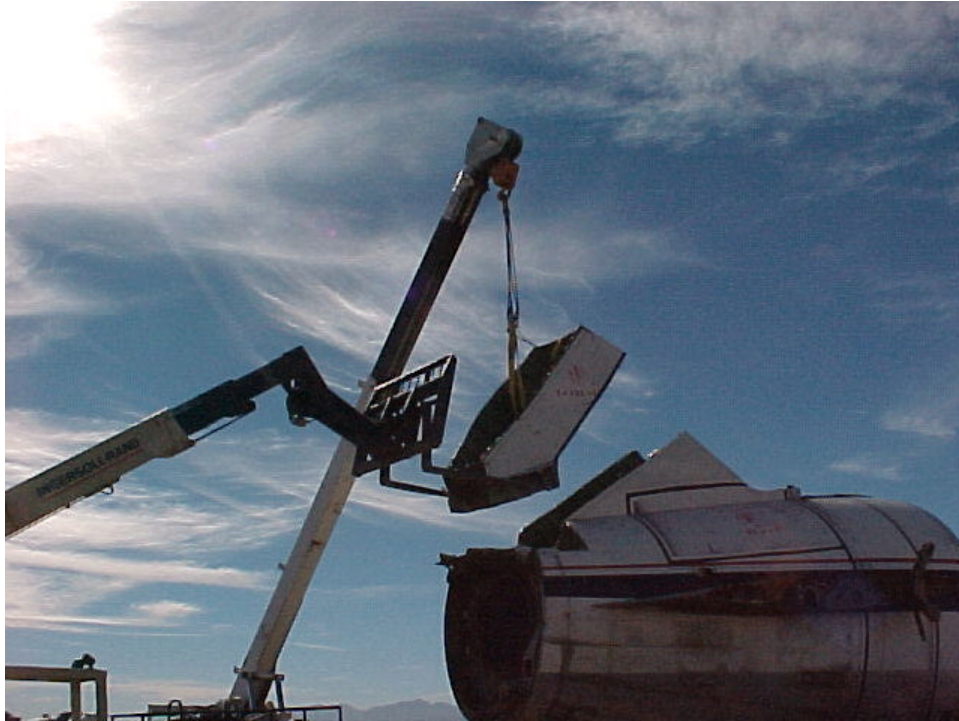
Figure 49: Removing FN1 and FN2

- A fork puncture through the rear spar web occurred when titanium angels nested in the rear spar chords were inadvertently left un-cut when the rib was removed. The skin and stringers were already cut, so there was no damage or overload to FN1 or FN2.

Figure 49: Removing FN1 and FN2

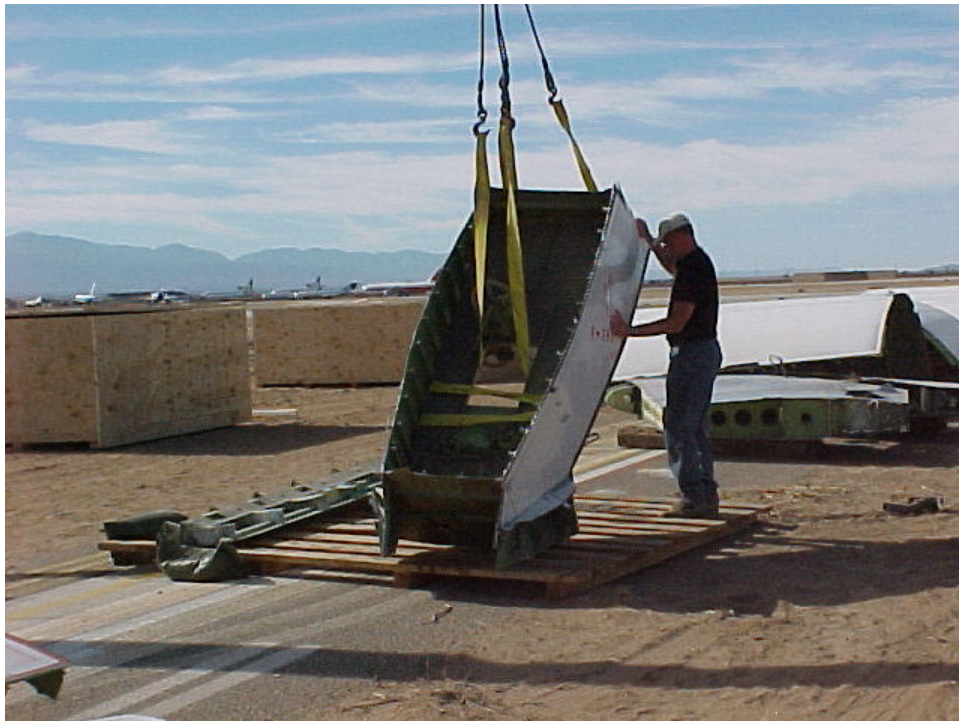
Figure 50: Lowering FN1/FN2 to the staging pallet

Figure 50: Lowering FN1/FN2 to the staging pallet

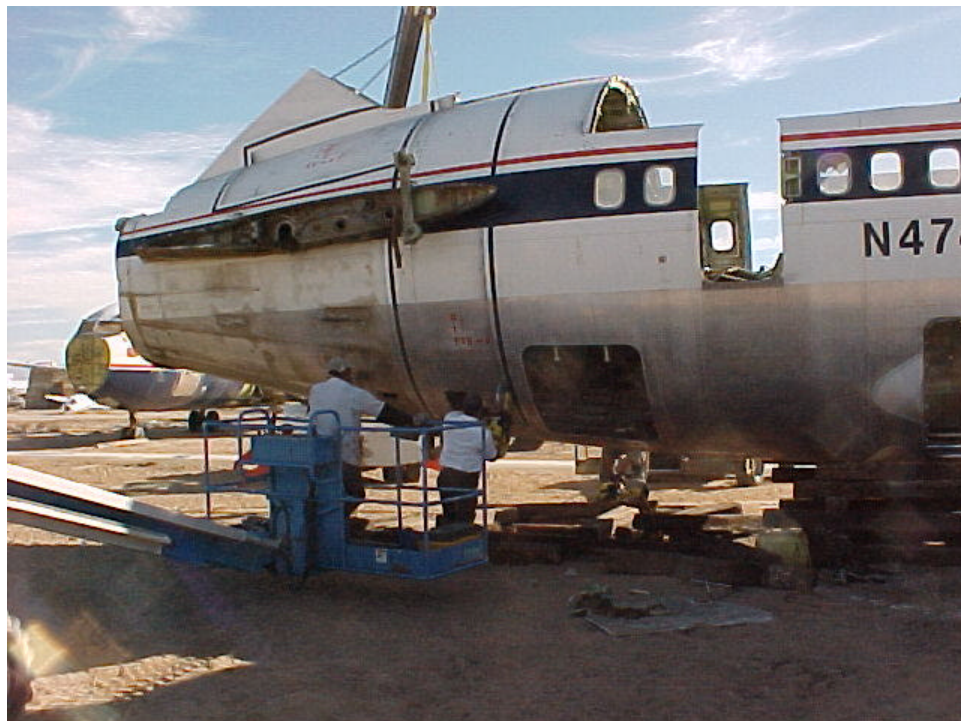
Figure 52: Undercut to remove Section 48

Figure 52: Undercut to remove Section 48

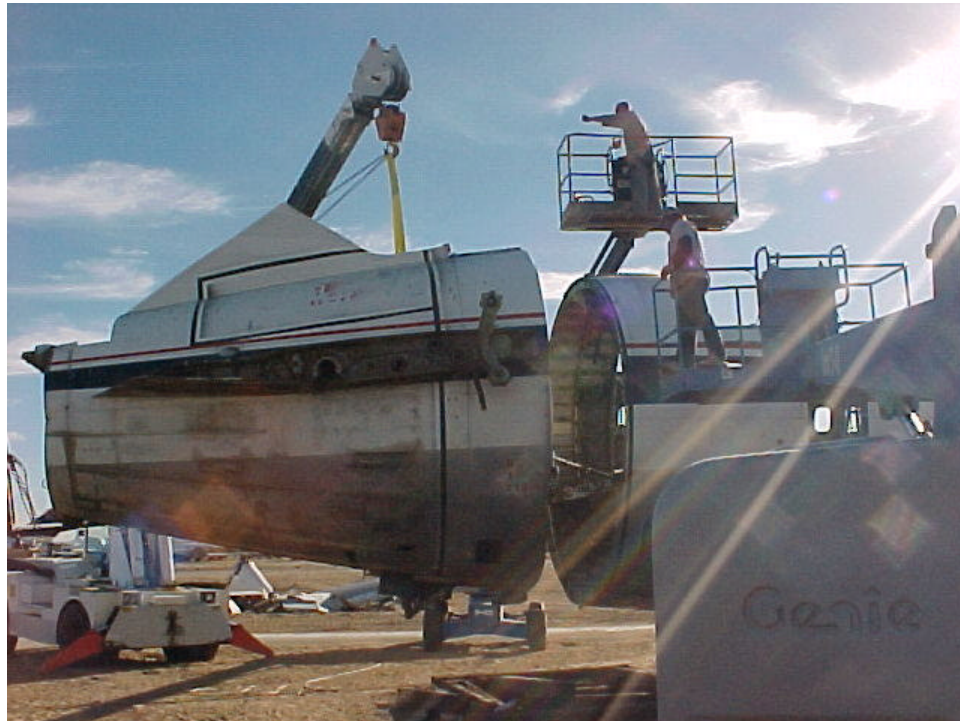
Figure 53: Section 48 separated

Figure 53: Section 48 separated

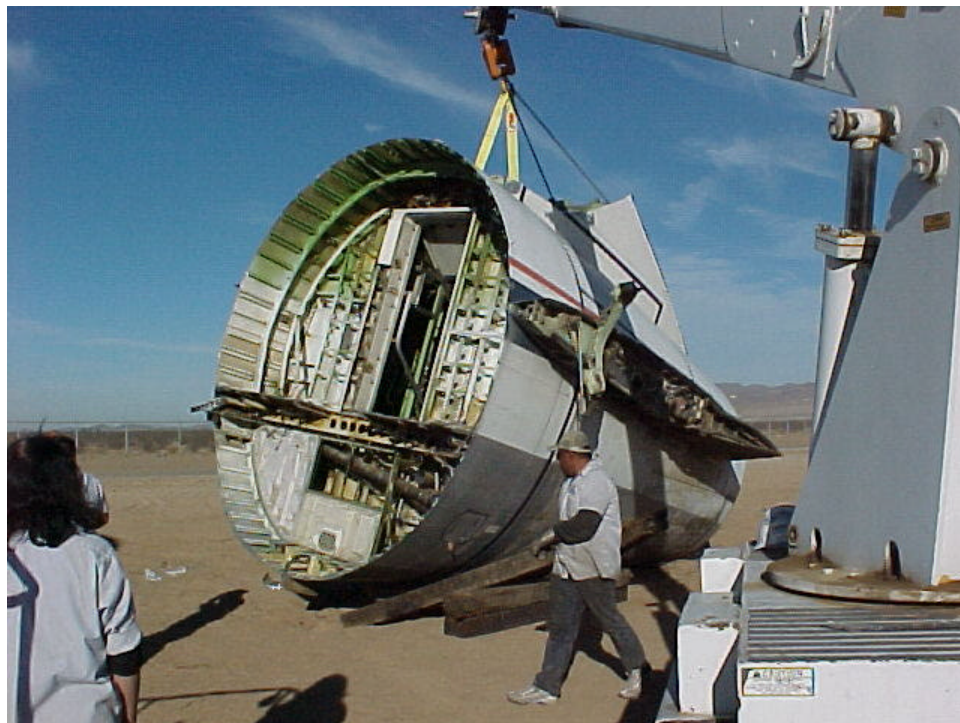
Figure 54: Section 48 stabilized

Figure 54: Section 48 stabilized

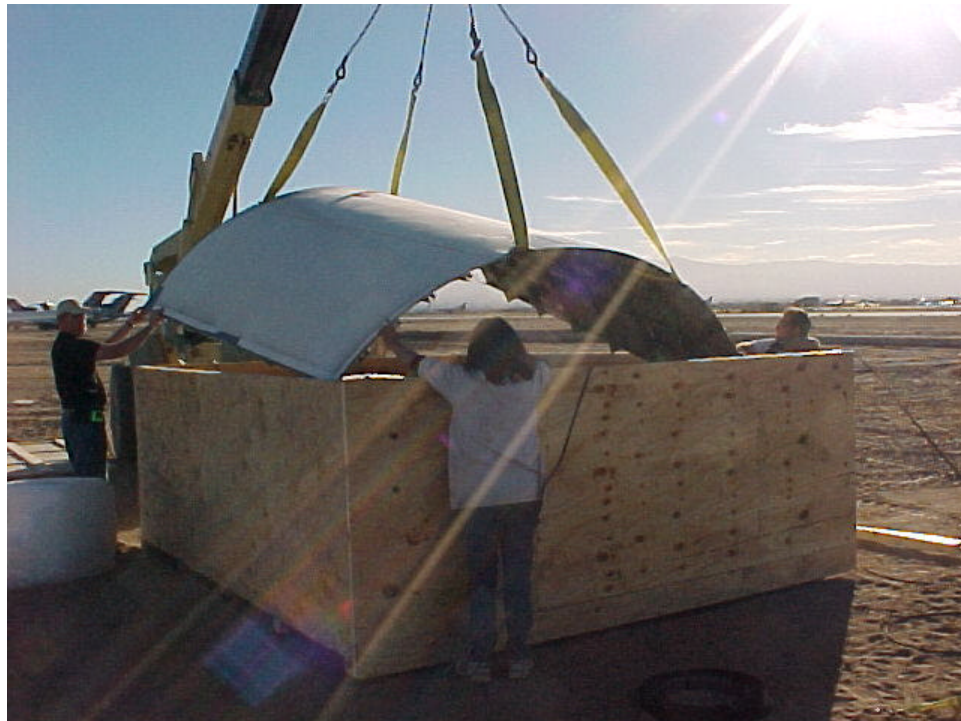
Figure 56: F3/FT1 lowered into its box

- Slack from the lift straps was removed by hand-tightening. Still, over-tightening by hand led to a small skin crack in the right forward edge of F3/FT1. This crack is well contained within the rough area that will be removed from the FASTER test panel, so it does not affect the test specimen.

Figure 56: F3/FT1 lowered into its box

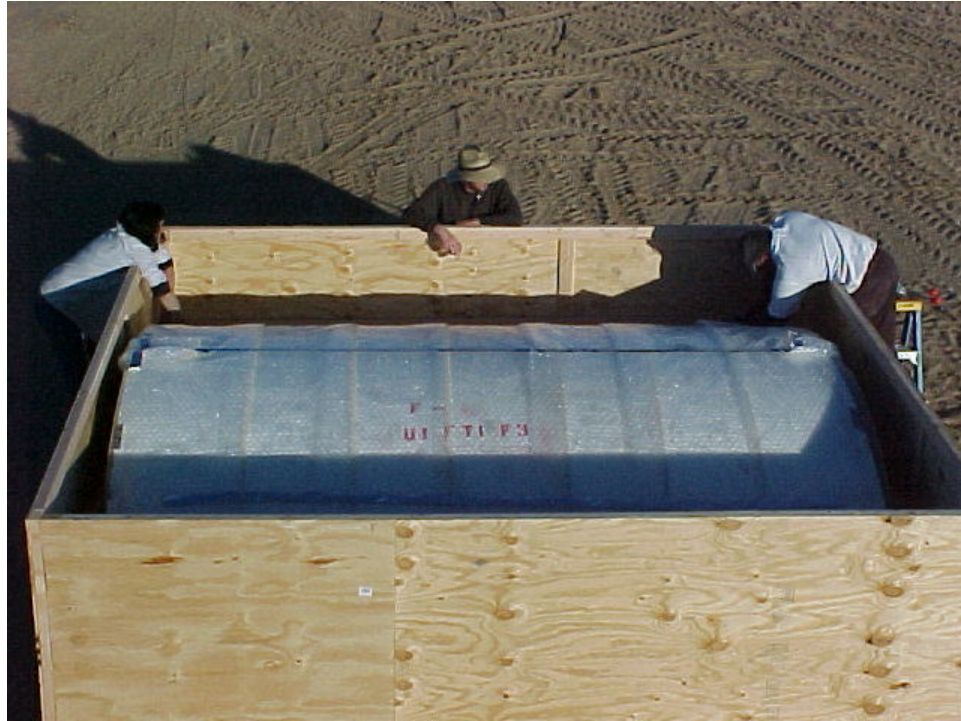
Figure 57: F3/FT1 banded and bubble-wrapped

Figure 57: F3/FT1 banded and bubble-wrapped

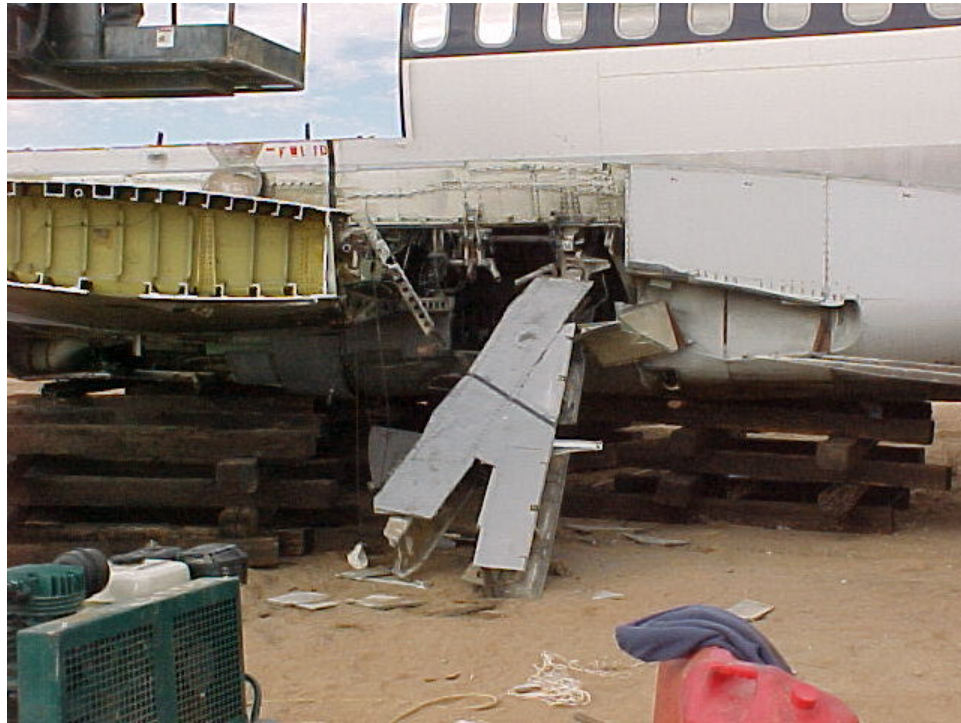
Figure 59: Left and right wing fairings and MLG beams removed

Figure 59: Left and right wing fairings and MLG beams removed

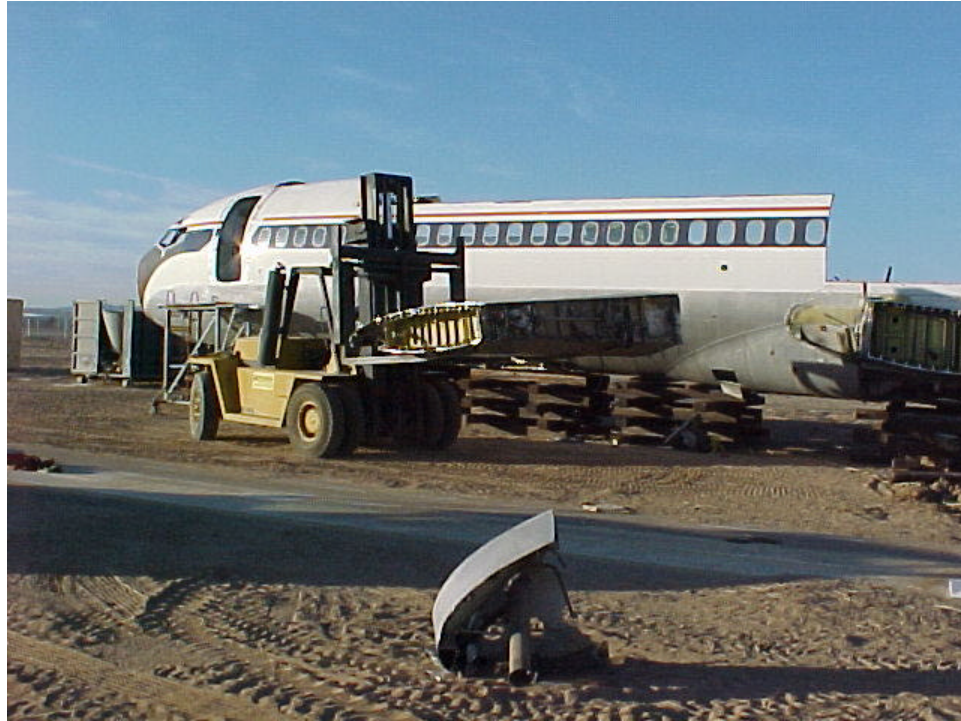
Figure 61: Left wing stub removed

Figure 61: Left wing stub removed

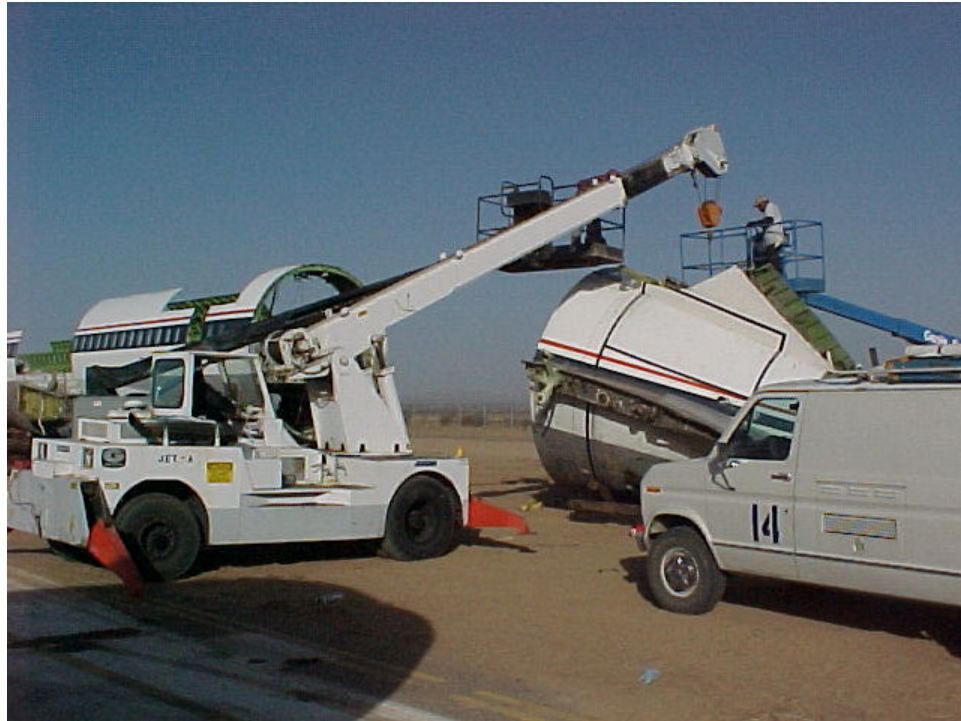
Figure 63: Cutting FT6 from Section 48

- Began cuts to separate aft pressure bulkhead (FT6) from Section 48
 - Loosened S-duct for access. S-duct cannot be removed intact.
 - Cut through No. 1 and No. 3 engine pylons
 - Cut through No. 2 engine pylon and vertical stabilizer front spar structure
 - Cut through Section 48 skin except for area under ventral stairway (tail-strike damper backup structure)
- Aircraft was stabilized against rolling in high winds
- Removed cabin floor panels above centerwing.
- Prepared right side-of-body rib (W2 and W4) for removal
 - Removed ducting for climate control systems
 - Removed center wing tank access plates
 - Marked cut lines for front spar and rib access hole

Figure 63: Cutting FT6 from Section 48

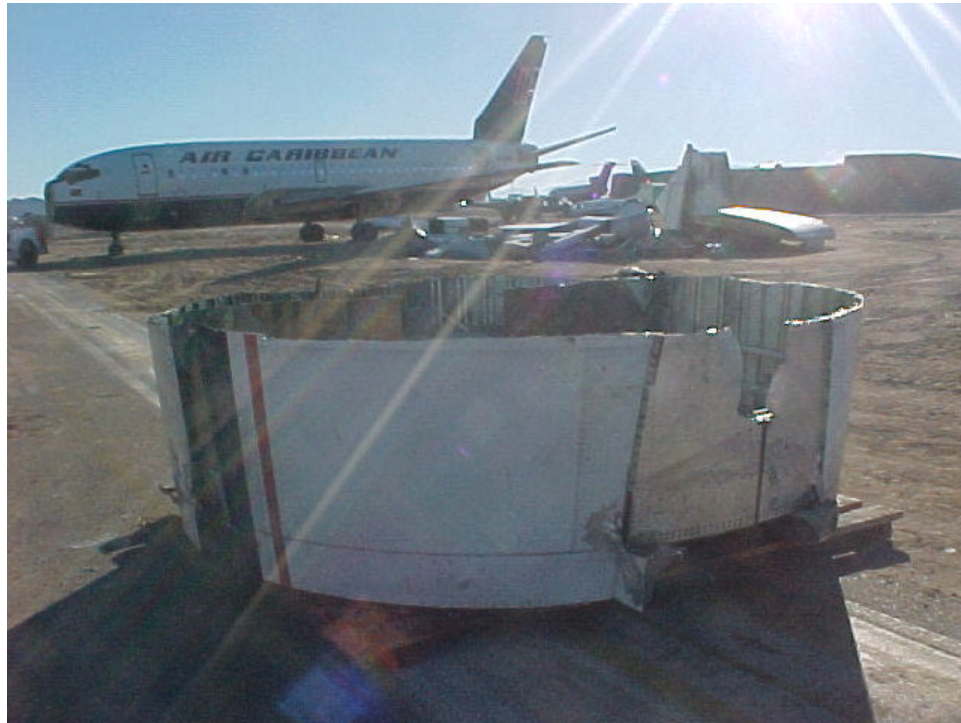
Figure 67: Aft pressure bulkhead (FT6) banded to shipping pallet

Figure 67: Aft pressure bulkhead (FT6) banded to shipping pallet

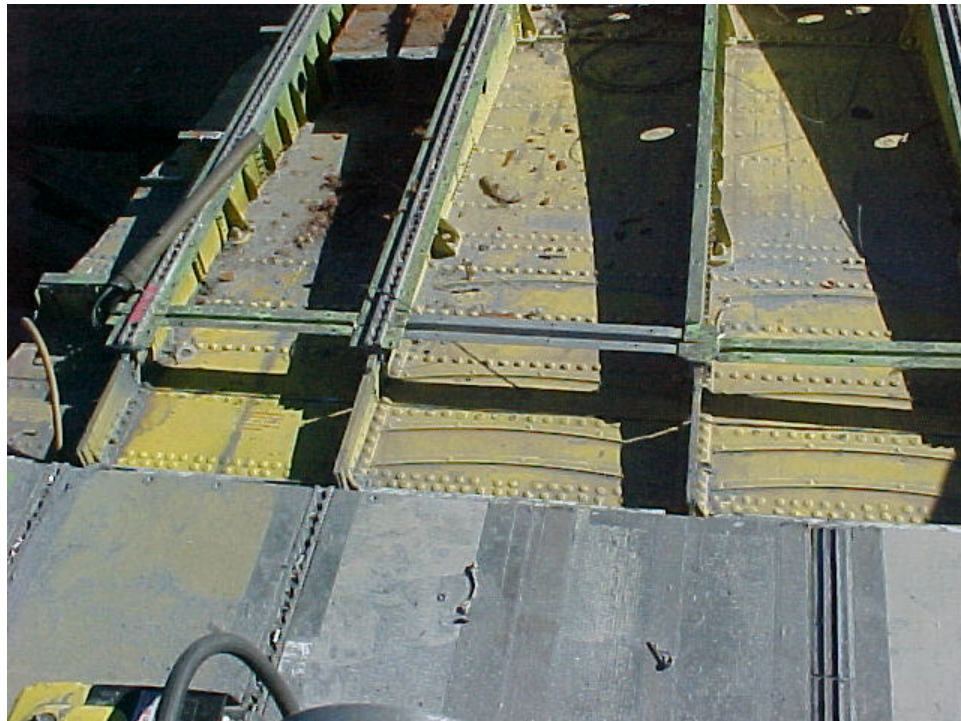
Figure 68: Cuts through longitudinal floor beams and upper centerwing skin

Figure 68: Cuts through longitudinal floor beams and upper centerwing skin

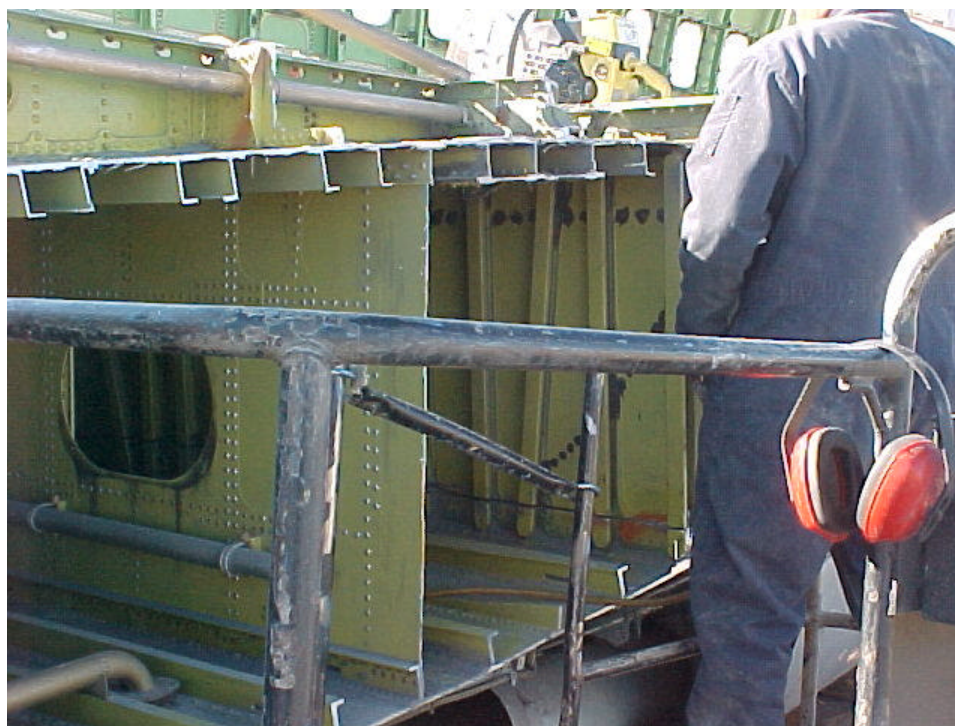
Figure 69: Front spar web cut just above lower cap

Figure 69: Front spar web cut just above lower cap

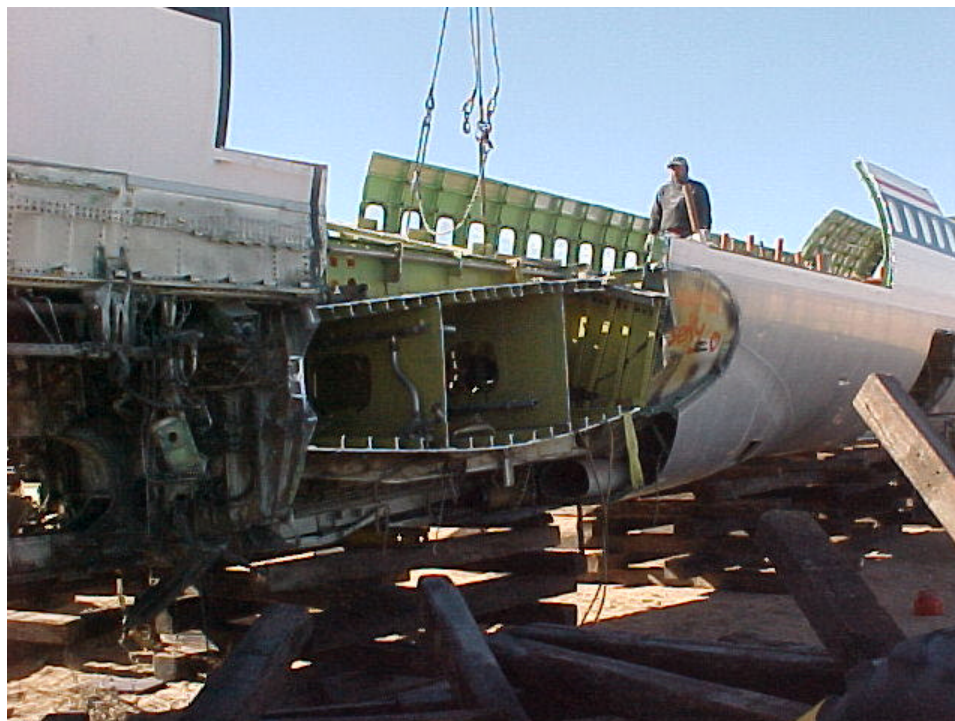
Figure 70: Front spar lifted

Figure 70: Front spar lifted

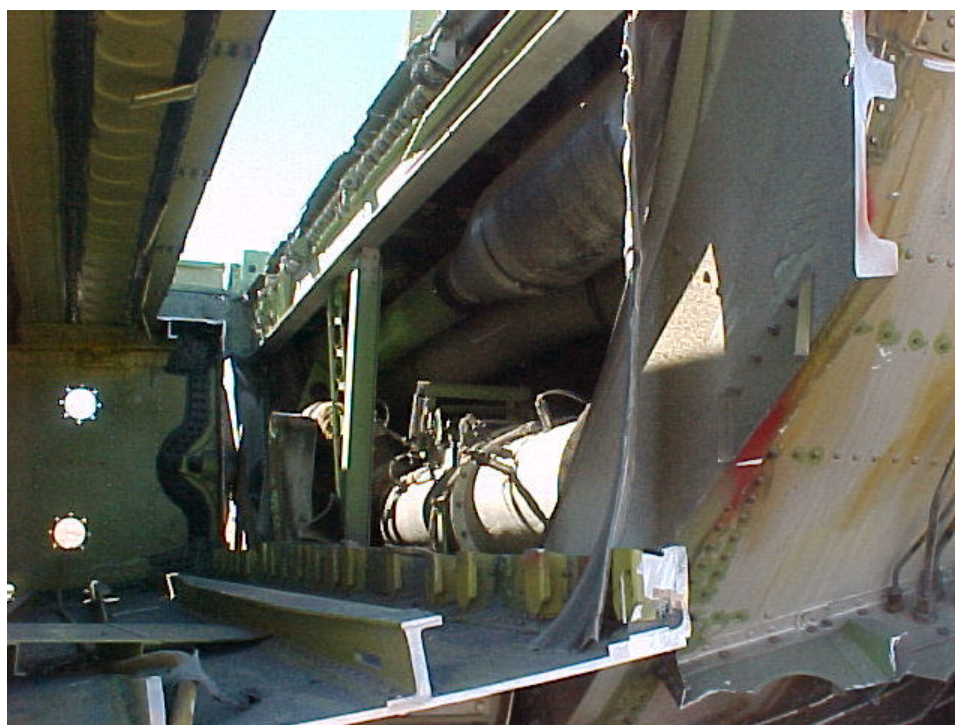
Figure 71: Front spar lower cap left in aircraft

Figure 71: Front spar lower cap left in aircraft

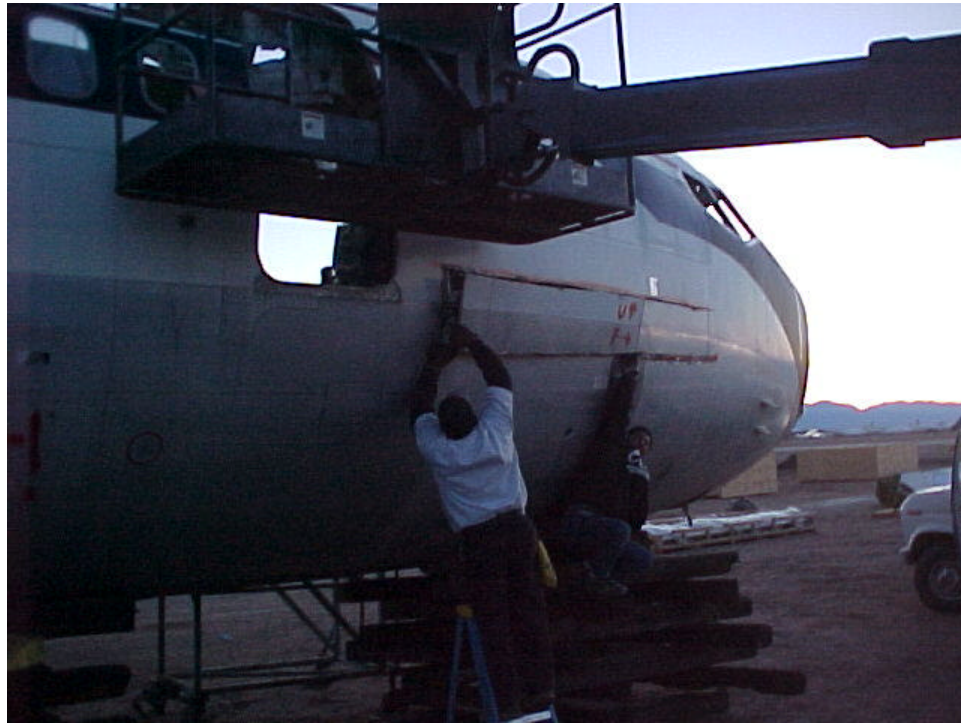
Figure 72: Removing Section 41 frames at floorline (F14)

Figure 72: Removing Section 41 skin, frames, and floor structure at floorline (F14)
